VERTICAL DEFORMATION ANALYSIS BASED ON REPEATED MEASUREMENTS OF A SHOPPING BUILDING**АНАЛИЗ ВЕРТИКАЛЬНОЙ ДЕФОРМАЦИИ НА ОСНОВЕ ПОВТОРНЫХ ИЗМЕРЕНИЙ ТОРГОВОГО ЦЕНТРА**

For the vertical deformation monitoring of the construction of the Family Park shopping centre facility in Samarkand, Uzbekistan, a monitoring network has been established including 12 benchmarks installed on the wall of the building. Altogether 8 of control surveys were observed during the time span of the construction, and based on them, an estimation for future subsidence has been provided by extrapolating of best-fitting exponential curve. It was found that in all test points the relevant subsidence has been ceased. A further test has been provided to estimate the tilting of the building. The value of the tilting was estimated to be 0.06‰, which was also found to be unidirectional, so no deformation of the structure can be expected due to it.

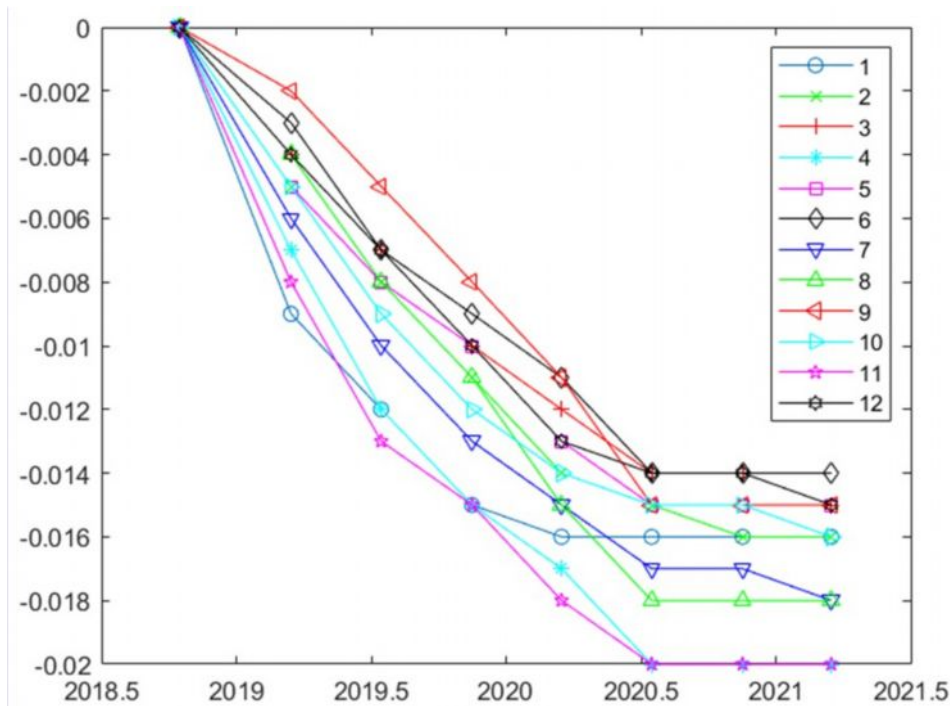
Altogether 8 epochs were observed over a period of 2.5 years in order to monitor the subsidence of the structure. Based on that the subsidence of the building can be determined. Table 1 shows the subsidence values with respect to the null measurement on October, 2018. Time series of the subsidence in each test points are displayed on Figure 2. According to Table 1 and Figure 2, the whole building shows an obvious sinking, although the speed of subsidence is different at the different test points.

Figure 2. Subsidence of the leveling marks determined with respect to the null epoch (Oct. 2018). Unit: on the abscissa axis - years, on the ordinate axis – mm

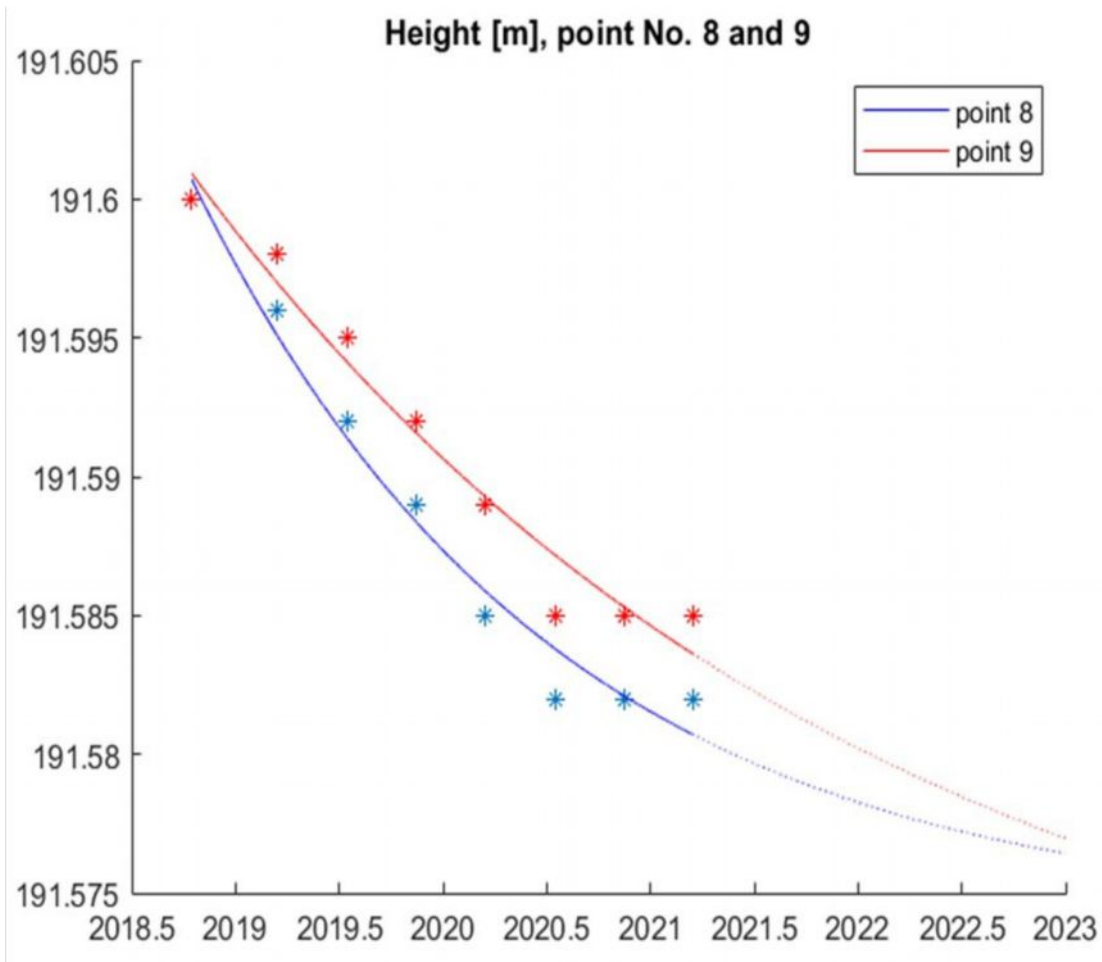
According to Table 2, the predicted amount of future subsidence is 1-2 mm in all test points except for points 8 and 9. Note, however that in these two cases the goodness of fitting the

exponential curve is the least convincing, c.f. the corresponding values of R^2 and RMS. Figure 3 displays the time series and the prediction of these two points. As it can be seen on the Figure, the subsidence at these two test points has been completed by mid-2020, which could not be recovered by the fitted exponential curve. Consequently, the predicted future subsidence values are overestimations due to the incorrectness of the curve fitting. Summarily, in all test points the subsidence can be considered generally to be ceased.

Figure 3. Time series of heights above mean sea level of points 8 and 9, result of the fitted exponential curve and the prediction. Unit: on the abscissa axis - years, on the ordinate axis – m

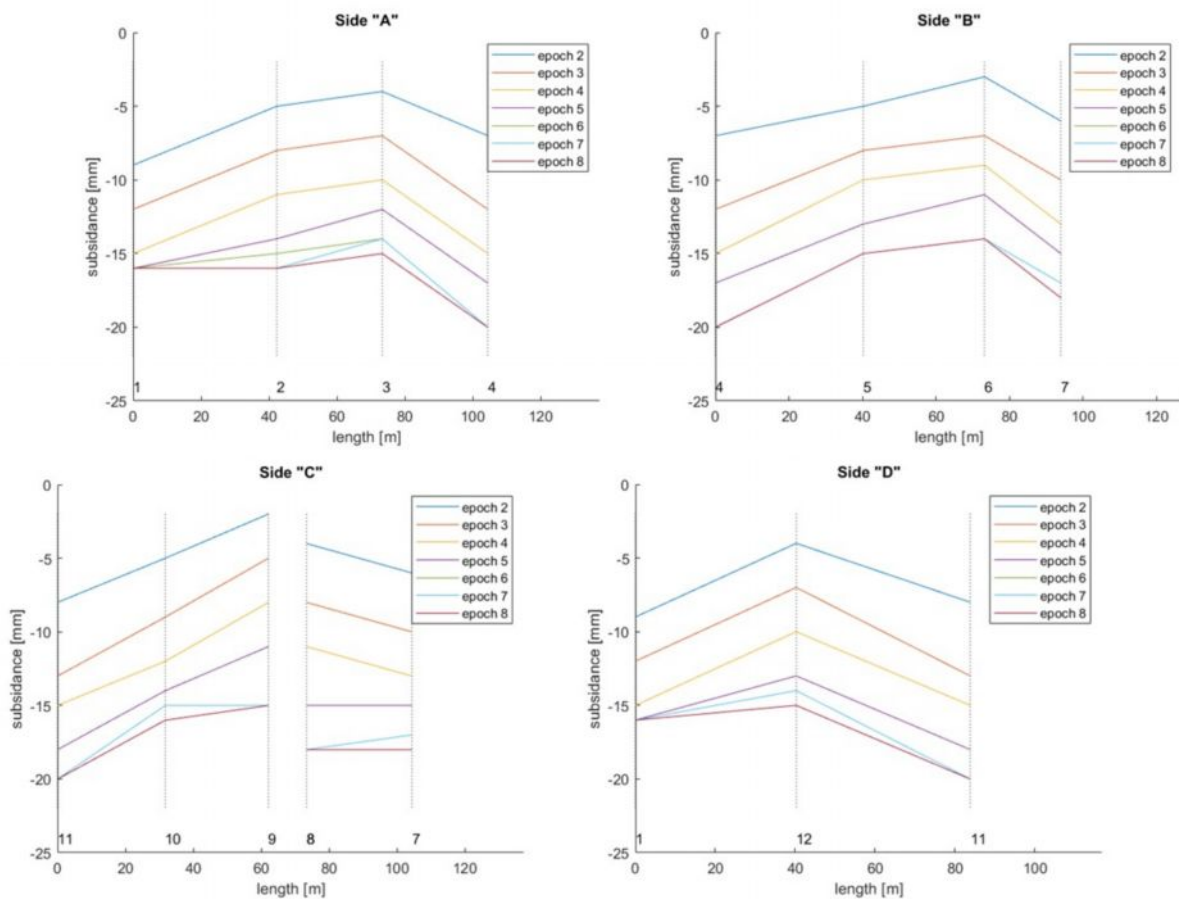
Figure 5. Subsidence of the building sides by time.

The subsidence differences along each side are in the range of 3-4 mm (c.f. Figure 5), which is very similar to the measurement accuracy ($\pm 1-3$ mm, c.f. chapter 2). Apparently, many of these subsidence variations along the sides are partially the consequence of the measurement errors. Furthermore, the structure can deform only to a limited extent, so none of the subsidence values can be taken as a “ground truth”, thus only main tendencies are attempted to be captured. This is done by fitting a linear regression line to each side. The slopes of the resulting lines are $-6.2''$, $+6.3''$, $+16.7''$ and $-10.0''$ respectively for the “A”, “B”, “C” and “D” sides (the sign of the subsidence is considered by following the increasing order of the test point numbering). Accordingly, the estimated height differences (relatively to the first test point of the corresponding side) are -3.1 mm (point 4), $+2.8$ mm (point 7), -0.5 mm (point 8), $+5.0$ mm (at the corner between points 8 and 9), and -4.1 mm (point 11). By cumulatively summing the subsidence values along the different sides, the closure error becomes 0.1 mm, which is surprisingly small in the view of the roughness of the estimation method. The cumulative summation results in a subsidence model with values relatively to test point 1. The relative subsidence values are -3.1 mm (point 4), -0.3 mm (point 7), -0.3 mm (point 8), -0.8 mm (at the corner between points 8 and 9), and 4.3 mm (point 11). The relative subsidence model is presented on Figure 6. Based on this figure, there is an obvious tilting in the direction of the lines of points 4 and 11, approximately perpendicularly to the axis going through points 1 and 7. Considering the size of the building (c.f. Figure 1), the tilting is estimated to be 0.06‰ (7.4 mm along a 133.9 m line). Furthermore, we can conclude that the tilting of the building is unidirectional, so no deformation on the structure due to it can be expected.

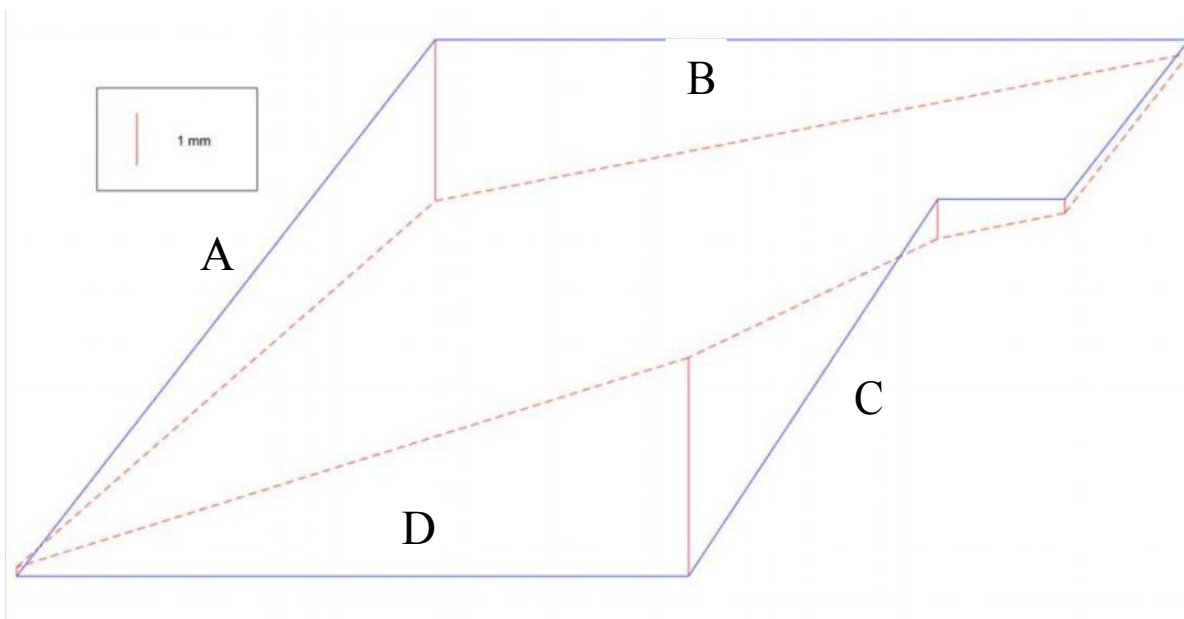
Figure 6. The relative subsidence model. The blue line indicates the floor plan in a tilted view, and the relative subsidence is red. The direction of the relative subsidence (up or down) at the test points indicates the sign.

A further test has been provided to estimate the tilting of the building. Due to the small signal, which is comparable with the measurement accuracy, simplified subsidence characteristics for all the sides of the building was determined by linear regression, and taking into account the corresponding slopes, a subsidence model in relative sense has been derived. The subsidence model has provided a small closure error, the results may indicate actual tilting. The value of the tilting was estimated to be 0.06‰ (7.4 mm along a 133.9 m line) in the direction of the line going through points 4 and 11, approximately perpendicularly to the axis going through points 1 and 7.
